Solder Column Qualification for Ceramic Column Grid Array (CCGA) White Paper

**Aeroflex Colorado Springs
October 2006, Revised July 2008**

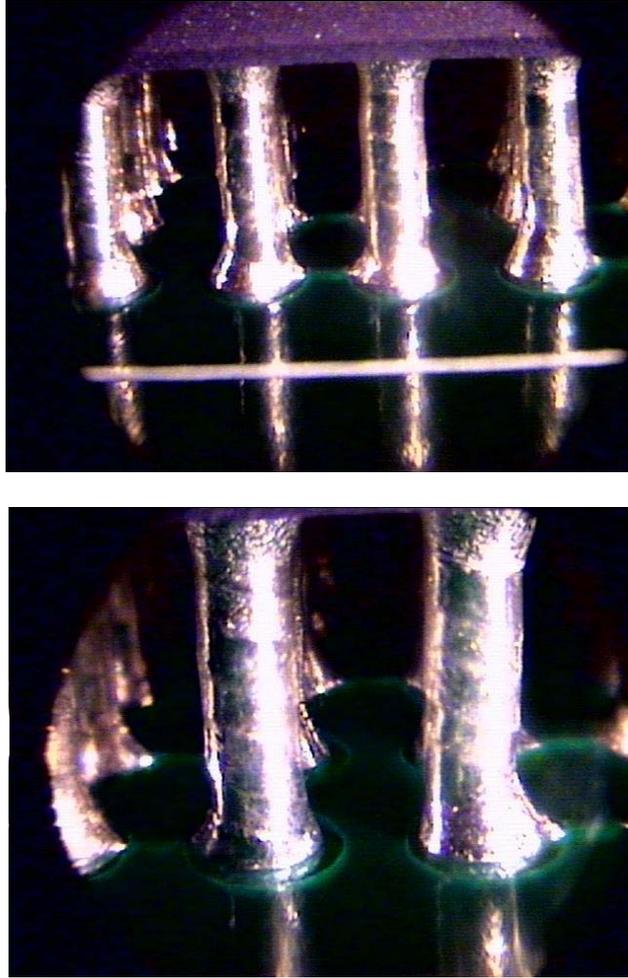
Figure 4. Zero stress solder column images.

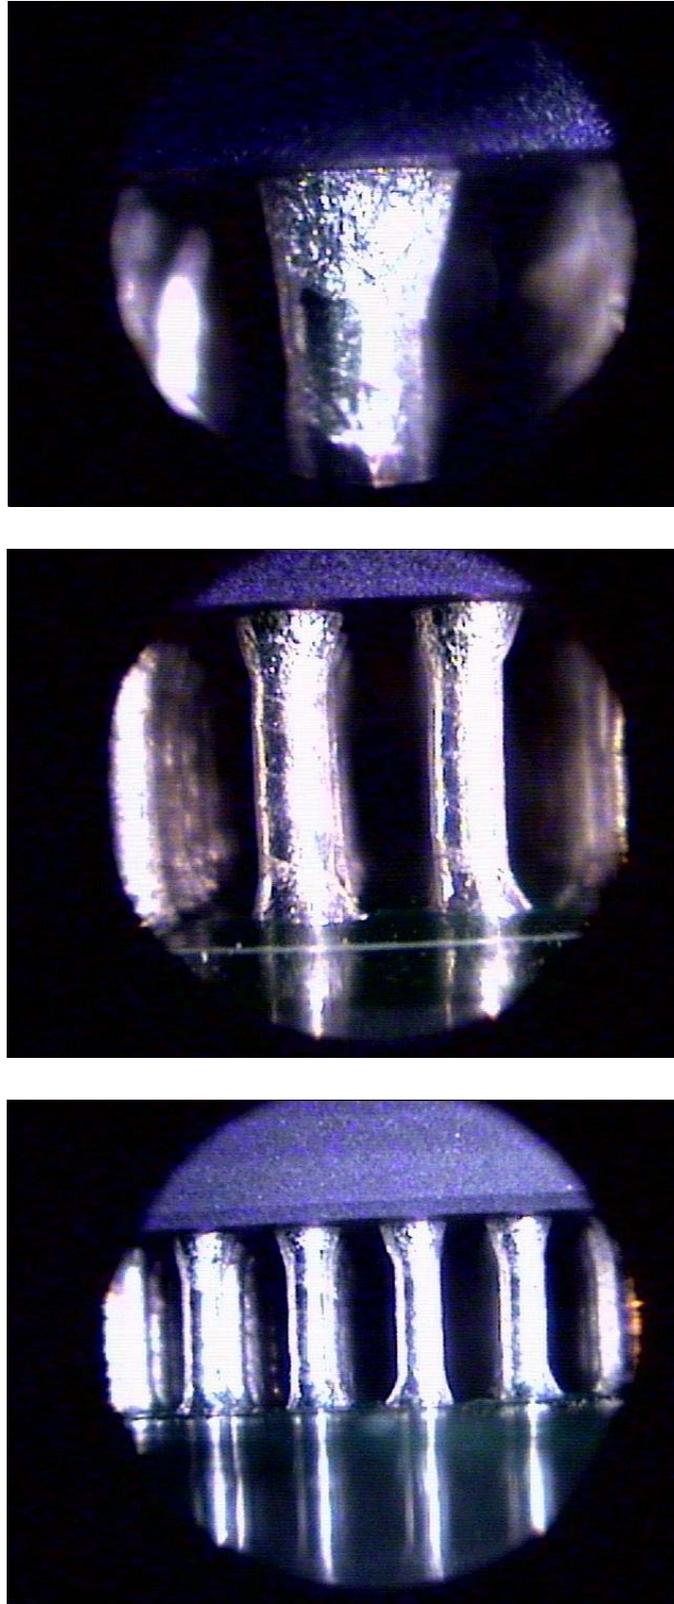
In summary, after 500 cycles of temperature and vibration HASS testing, there were not failures detected in the solder column itself or at the column attach interface to the package.

Figure 5. Post-HASS solder column images.

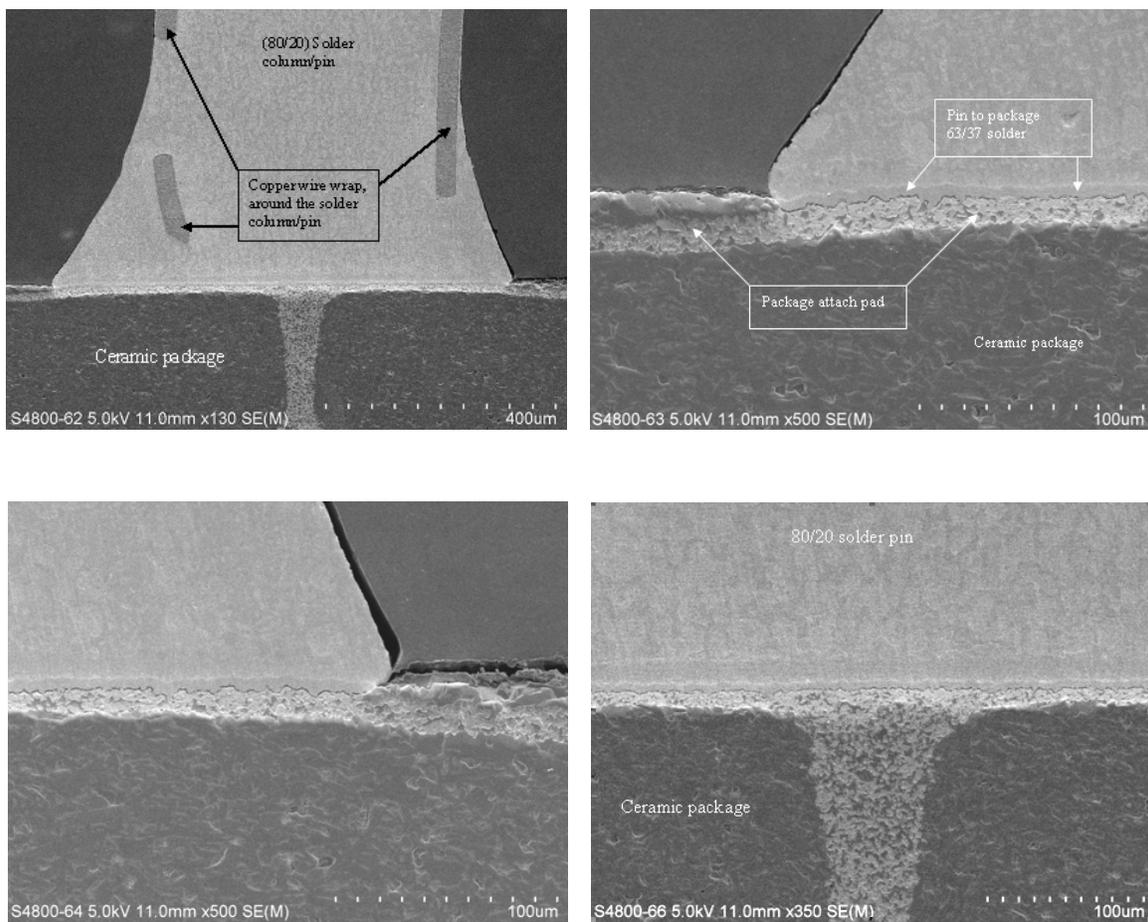
Results of the cross section analysis showed no apparent differences between stressed and unstressed packages within solder columns or column attach interfaces to the package.

Figure 7. Cross section SEM images of unstressed package.

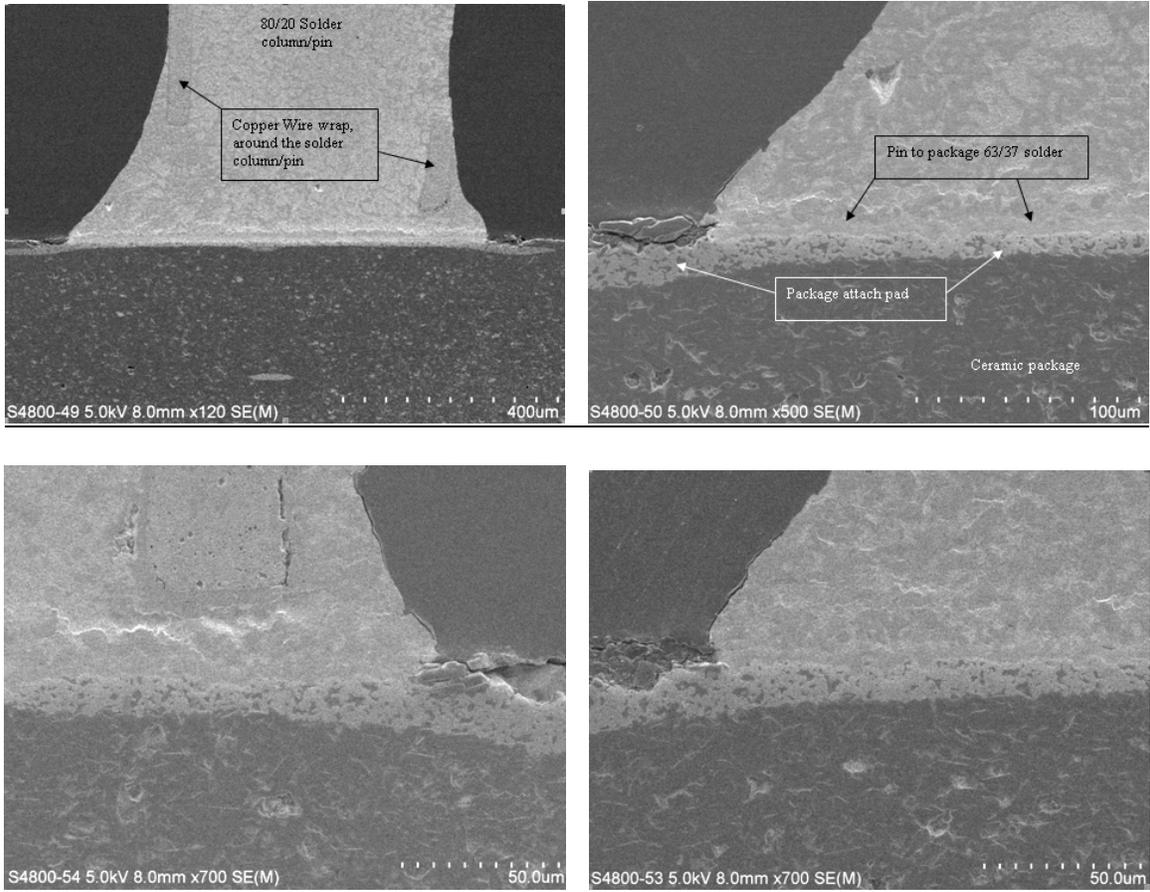
Figures 8. Cross section SEM images of stressed package.
