THERMAL CYCLING RELIABILITY ASSESSMENT OF A CERAMIC COLUMN GRID ARRAY¹ PACKAGE FOR SPACE APPLICATIONS²

Rajeshuni Ramesham, Ph.D.

Component Engineering and Assurance Office, Office of Safety and Mission Success
Jet Propulsion Laboratory, California Institute of Technology
4800 Oak Grove Dr., Mail Stop 11-111
Pasadena, CA 91109, USA
e-mail: Rajeshuni.Ramesham@jpl.nasa.gov

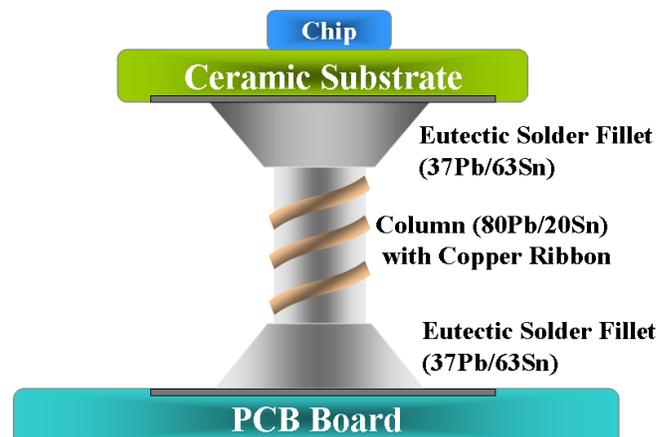
Figure 1. Schematic of a Column in a CCGA Package [1]

Ceramic column grid array (CCGA) technology is an advanced electronic interconnection packaging surface-mount technology (SMT) process. This advanced CCGA interconnect technology will significantly improve the performance of avionics/electronics systems. The failure mechanisms of CCGA interconnects are dependent on the materials of the columns and board, the solder-joint at the column/ceramic interface, column/board material interface, solder reflow temperature, and the solder materials employed. The most predominant failure mechanism is solder-joint fatigue during thermal cycling. Any coefficient of thermal expansion (CTE) mismatch between board material and columns or between columns and ceramic substrate causes shear displacement at each of the solder-joint interconnects, which may lead to fatigue failure during low thermal cycles, as well as during power cycling. Figure 1 shows the schematic of the 80Pb/20Sn column with copper spiral configuration in the CCGA package [1].

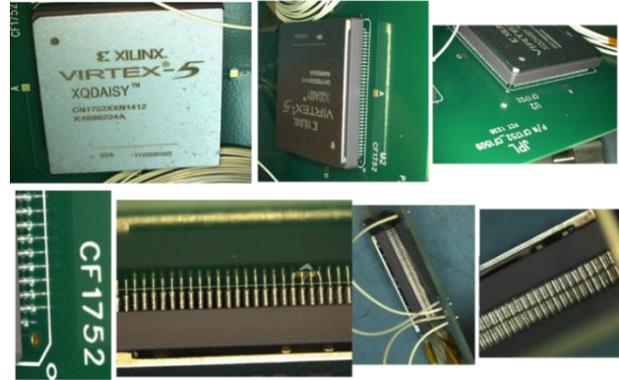
Figure 2. Optical Images of the CCGA Test Board before Thermal Cycling

The test boards were fabricated using SMT processes reported by Mehta and Bodie [3, 4]. They developed a process to qualify CCGA package assemblies using PWBs and daisy-chained CCGA 1752 (CN version) packages. Figure 2 shows optical photographs of our as-received CCGA packages prior to reflow and the reflowed packages at various magnifications. A complete CCGA 1752 array package is also shown in Figure 2. Copper spirals can be seen around the column interconnect material. The copper spiral is designed to increase the integrity of the column interconnect

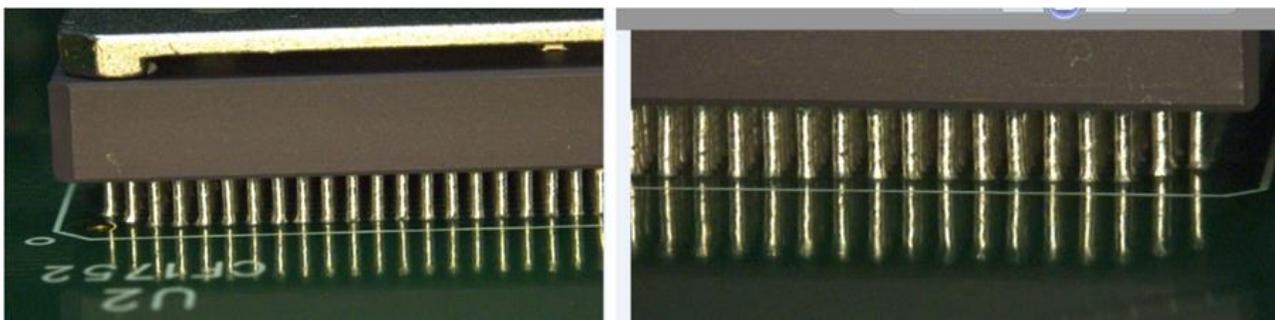
Figure 3. Optical Cross-Sectional Images of the CCGA Test Board before Thermal Cycling

during the solder reflow process. Figure 3 shows digital photographs of CCGA packages after they have been reflowed over the PWB. The complete CCGA package is magnified in Figure 3, showing the columns and the copper spirals around the columns. Figure 4 shows nondestructive x-ray images of the CCGA packages after solder reflow. There were no shorts and no overflow of solder materials that could affect the reliability of the CCGA packages, as is clear from the x-ray images.

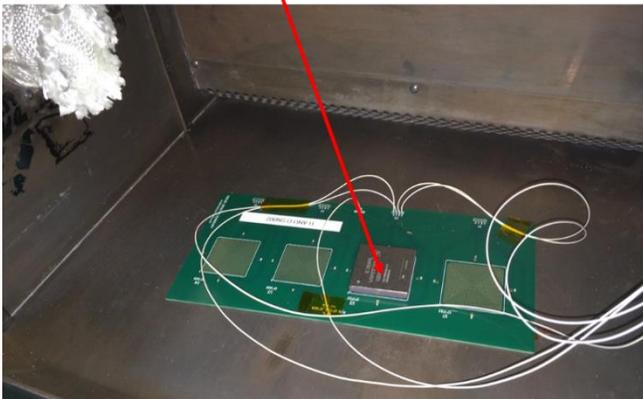
Figure 6. Optical Digital Image of the CCGA 1752 Daisy-Chain Test Board

Figure 6 shows the CCGA 1752 daisy-chained test board in a thermal atmospheric chamber that has been interfaced with the data logger⁵ to monitor the solder-joint resistance vs. thermal cycling. There were four daisy chains on this test board, one for each CCGA daisy-chain package. The value of the daisy-chain resistance was about ~2 Ω at room temperature. Testing was conducted to assess the advanced CCGA-interconnect technology's robustness to solder-joint failure. The key failure mechanism addressed in thermal

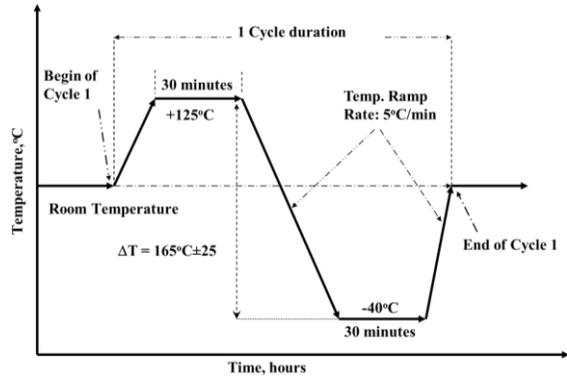
Figure 5. Extreme-Temperature Thermal Cycling Profile Used in This Study

Figure 5 shows the temperature profile employed for thermal cycling of the daisy-chained CCGA-interconnect test boards. The lowest temperature used was -40±25°C, and the highest temperature used was +125°C. The temperature ramp rate was 5°C per minute, and dwell time was 30 minutes on hot and cold temperatures during thermal cycling.

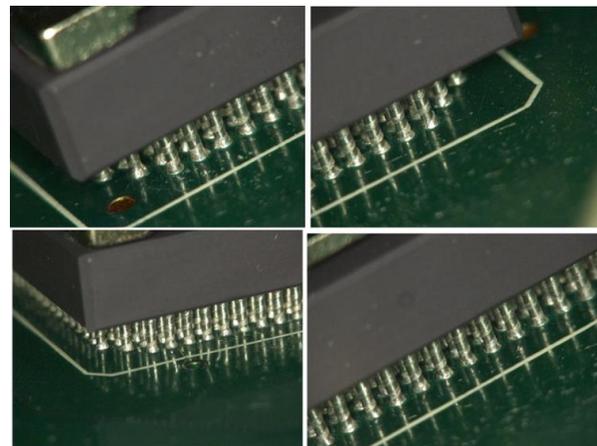
Figure 7. Optical Image of the CCGA 1752 Packages after 623 Thermal Cycles

cycling was solder-joint fracture at the board-and-column interface or at the column-and-ceramic-package-substrate surface. Temperature cycling in a gaseous nitrogen environment could result in thermal fatigue of the solder joint, and interdiffusion at the substrate, the column, or the column-and-substrate interface. The thermal stress depends on magnitude of the temperature (either on the high-temperature or low-temperature side), rate of temperature change, and range of temperature change (Delta T: ΔT), as well as the CTE of the materials combed in the configuration. High rate of temperature change (change in temperature per minute) could lead to thermal shock of the CCGA packages, which could have a catastrophic effect on the reliability of solder joints. Therefore, a low rate of temperature change (5°C per minute) was employed in this study. Figures 2 and 3, which show the CCGA test board before thermal cycling, are comparable to Figure 7, which shows the CCGA 1752 packages after 623 thermal cycles. No solder-joint issues were noted during or after 623 thermal cycles.

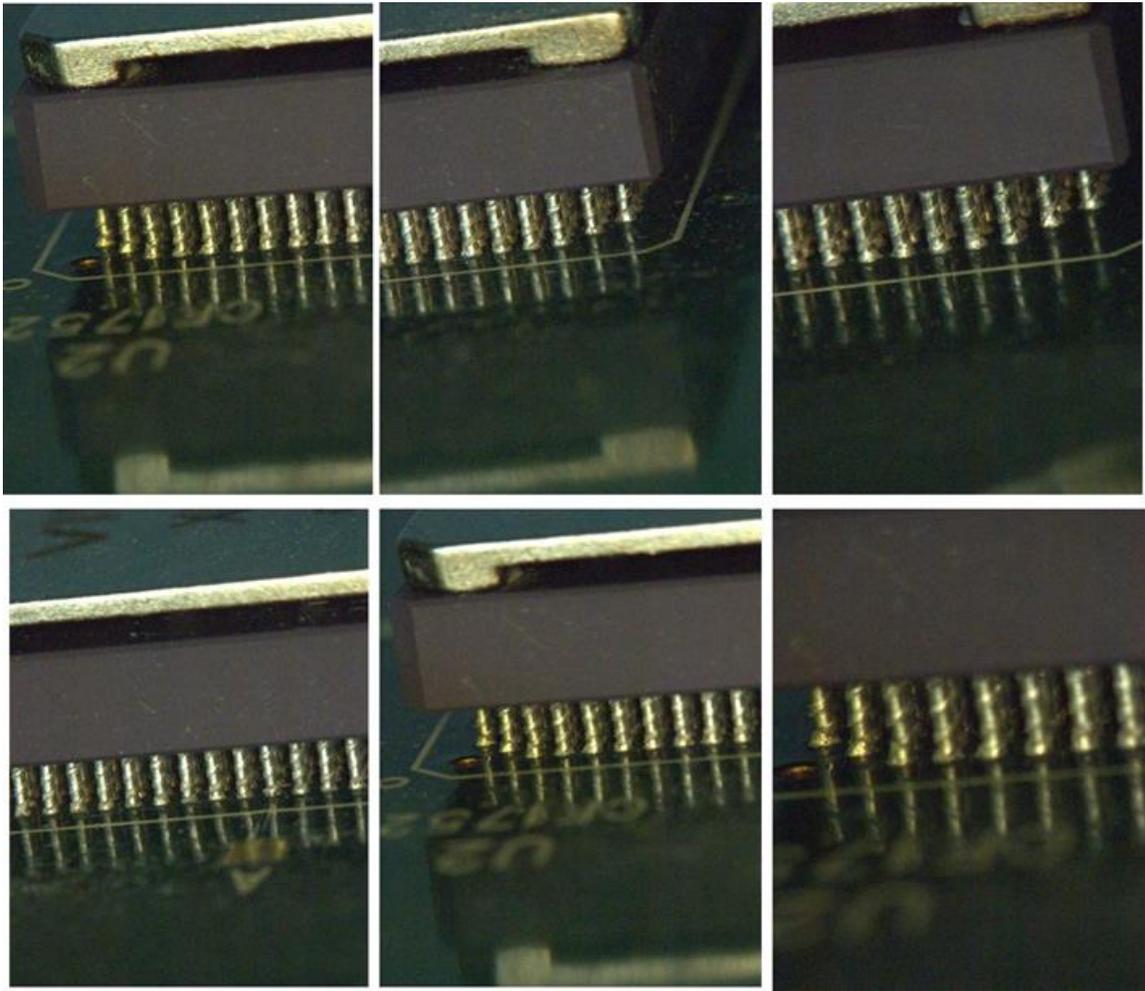
Figure 8. Optical Image of the CCGA 1752 Packages after 1460 Thermal Cycles

Figure 8 shows the optical image of the columns of CCGA 1752 packages after 1460 thermal cycles. No continuity issues were noted during or up to 1460 thermal cycles. After 1479 thermal cycles, however, we started to observe intermittent failures. Figure 9 shows the resistance of the daisy chains as a function of temperature cycling. Resistance of the solder joint increases as the temperature increases and decreases as the temperature decreases. Figure 9 shows the initiation of intermittent solder joint failures observed at 1479 cycles. Figure 10 shows the resistance of solder joints as a function of thermal cycles. The first solder joint failure was observed at the 1479th thermal cycle. The resistance of one of the daisy chains increased

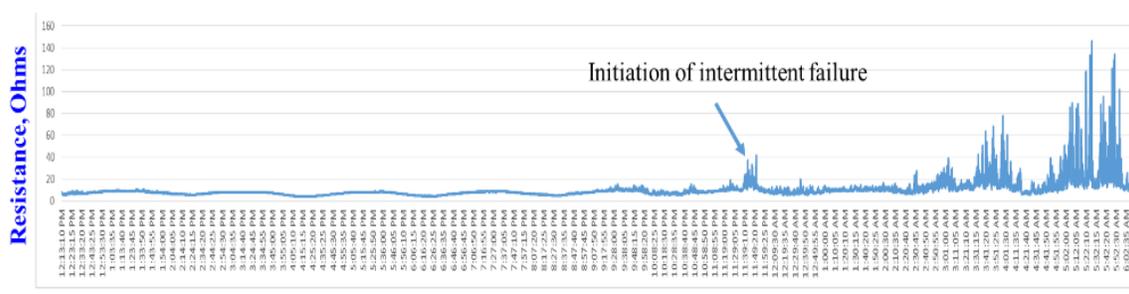
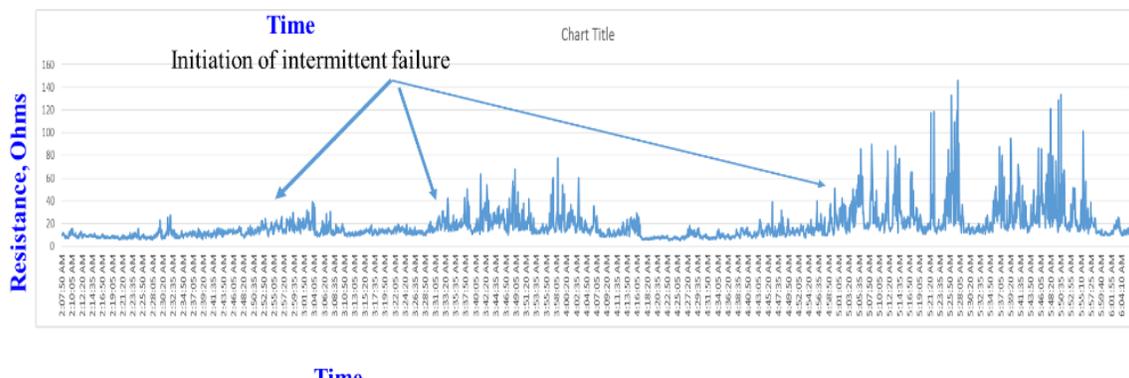
Figure 10. Daisy-Chain Resistance vs. Temperature during Thermal Cycling around 1479th Cycle

beyond 2 ohms and also beyond 100 ohms, as shown in Figures 10 and 11. More pronounced intermittent failures are shown in Figure 11. The increased resistance of the daisy chain to more than 10,000 ohms certainly provides reason to conclude that the daisy chain has failed. Figures 11 and 12 show the intermittent change in resistance to a higher value when the test article reached hot and cold temperatures for different daisy chains. The cause of daisy-chain failure during the hot and cold portion of the thermal cycle is clear. After 2500 thermal cycles, several daisy chains failed or cracked, as seen in Figures 13 and 14.

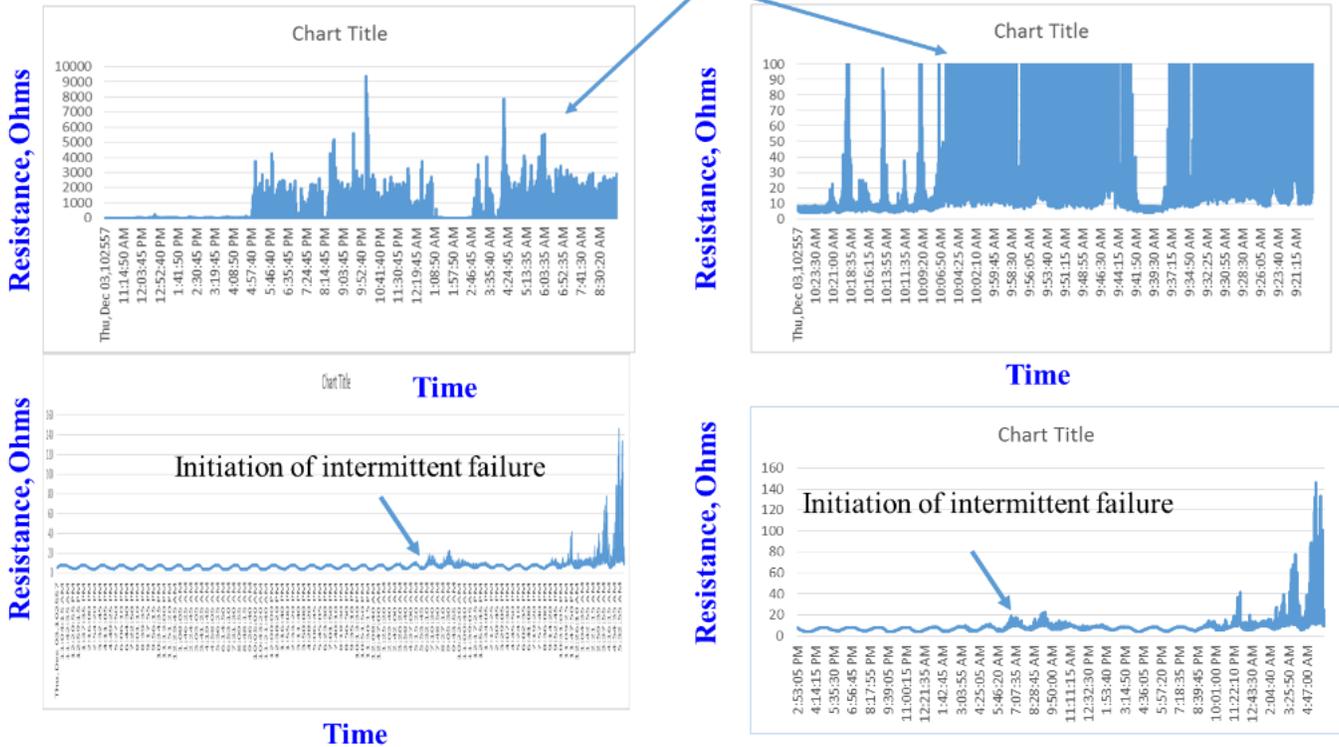
Figure 11. Daisy-Chain Resistance vs. material. For the 90Pb/10Sn column material, the first failure was observed at 1246 thermal cycles. Ghaffarian [8] reported that CCGA 717 input/output (I/O) modules showed. Time during Thermal Cycling around 1479th Cycle.

Continuous Intermittent failure

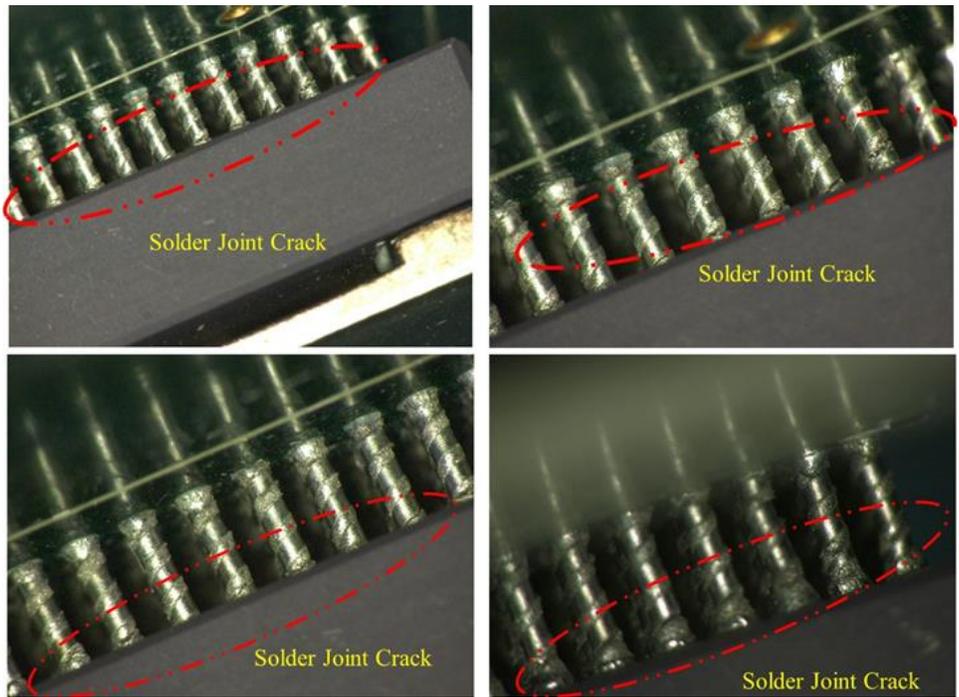
Figure 13: Optical image of the solder joints cracks after 2500 thermal cycles

The CCGA test articles were inspected prior to thermal cycling and after 623, 1460 and 2500 thermal cycles. The daisy chains were monitored continuously during the thermal cycling from the beginning of the test. Failures were observed in CCGAs tested under extreme-temperature thermal cycling. The first failure was observed in the test article at the 1479th thermal cycle performed from $-40^{\circ}\text{C}\pm 25$ to $+125^{\circ}\text{C}$. This failure was intermittent but reproduced in subsequent thermal cycles. There were several failures during the complete thermal cycling test for 2500 cycles. The ΔT of this test was 165°C , which is slightly more than NASA standard thermal cycles ($\Delta T = 155^{\circ}\text{C}$; temperature range = -55°C to $+100^{\circ}\text{C}$). The CCGA solder joint showed an open circuit or high resistance when the board was at high temperature and a closed circuit when the board was at low temperature and *vice versa*. Figures 13 and 14 show optical photographs of the complete CCGA packages as inspected after 2500 thermal cycles. Several micrographs show significant damage to solder joints, particularly notably at the corners of the package. Some of the columns are cracked and displaced from their original solder-joint position. Several cracks in the solder joints were observed. The failures occurred at the column-and-board interface and at the column-and-ceramic interface. Figures 13 and 14 clearly show the failed solder joints, cracking of the column interconnects, and displacement of columns from their original position, especially at the corners of the package.

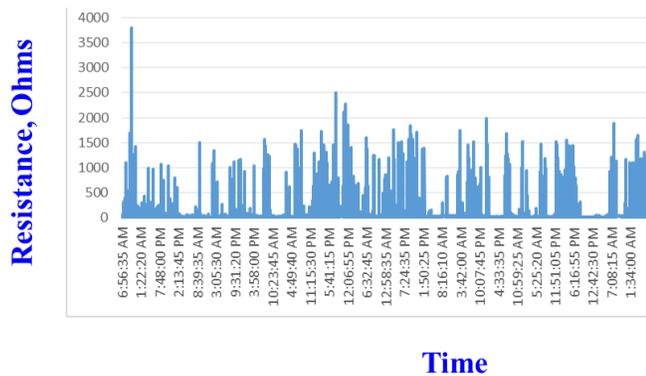
Figure 15. Resistance vs. Time around 2500 Thermal Cycles

At 2500 thermal cycles, intermittent failure of the daisy chain was further pronounced, as shown in Figure 15.
