Solder Column Qualification for Ceramic Column Grid Array (CCGA) White Paper

**Aeroflex Colorado Springs
October 2006, Revised July 2008**

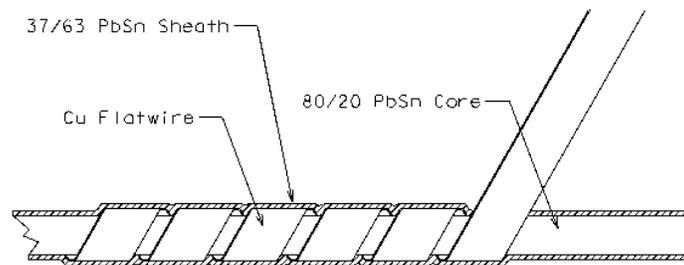
Figure 2. Six Sigma Services solder column construction.

The solder column is constructed of 80Pb/20Sn solder wrapped in a copper ribbon. The wrapped column is then tinned with eutectic solder. The product is cut in lengths of 87 mils and has a diameter of 22 mils.

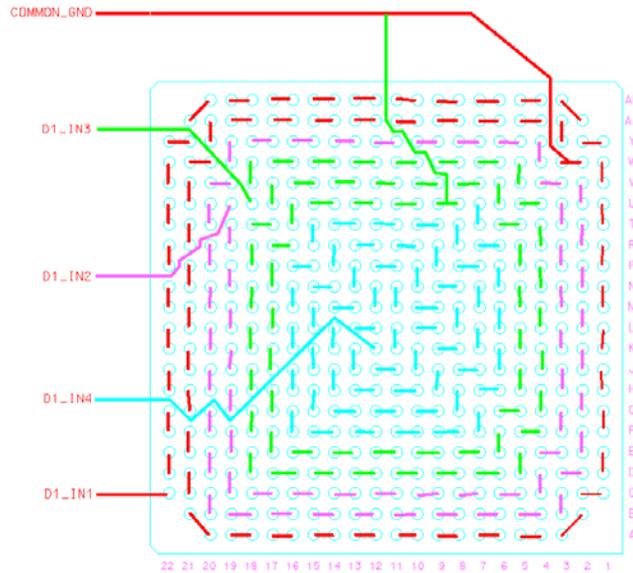
Figure 3. 472 pin CCGA daisy chain structure.

Each assembled package position has four monitored sections.

- IN1: Outer two perimeter columns.
- IN2: Next two inner rows of columns.
- IN3: Next two inner rows of columns after IN2.
- IN4: Center rows of columns.

This design was implemented to help isolate the location of daisy-chain failures. Specifically, the columns furthest away from the center of the package will typically experience the highest level of stress during testing.
